2021 Eurasian Watermilfoil Surveys

Round & Little Round Lakes, Sawyer County, WI

- Surveys Completed September 3-5th, 2021 –
- Report Completed December 2021 -

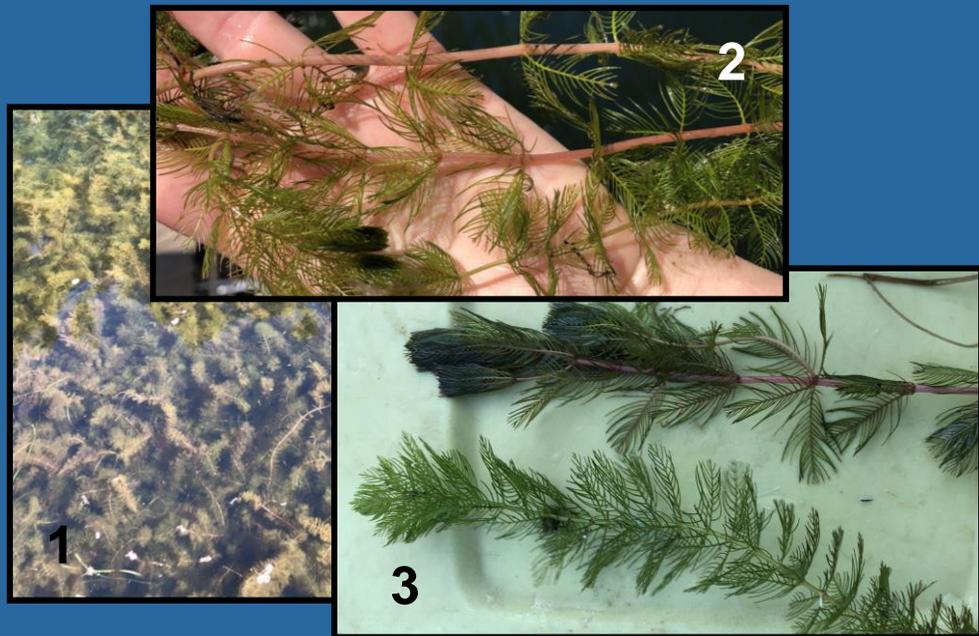
Photos from Cover Page: 1) A dense bed of canopied Eurasian watermilfoil found in Edgewater Bay (bed ED-A21, 0.3 acres) 2) Eurasian watermilfoil sample collected from Edgewater Bay. 3) Eurasian watermilfoil (top) and northern water milfoil (bottom, native) collected from Blue Island Bay.

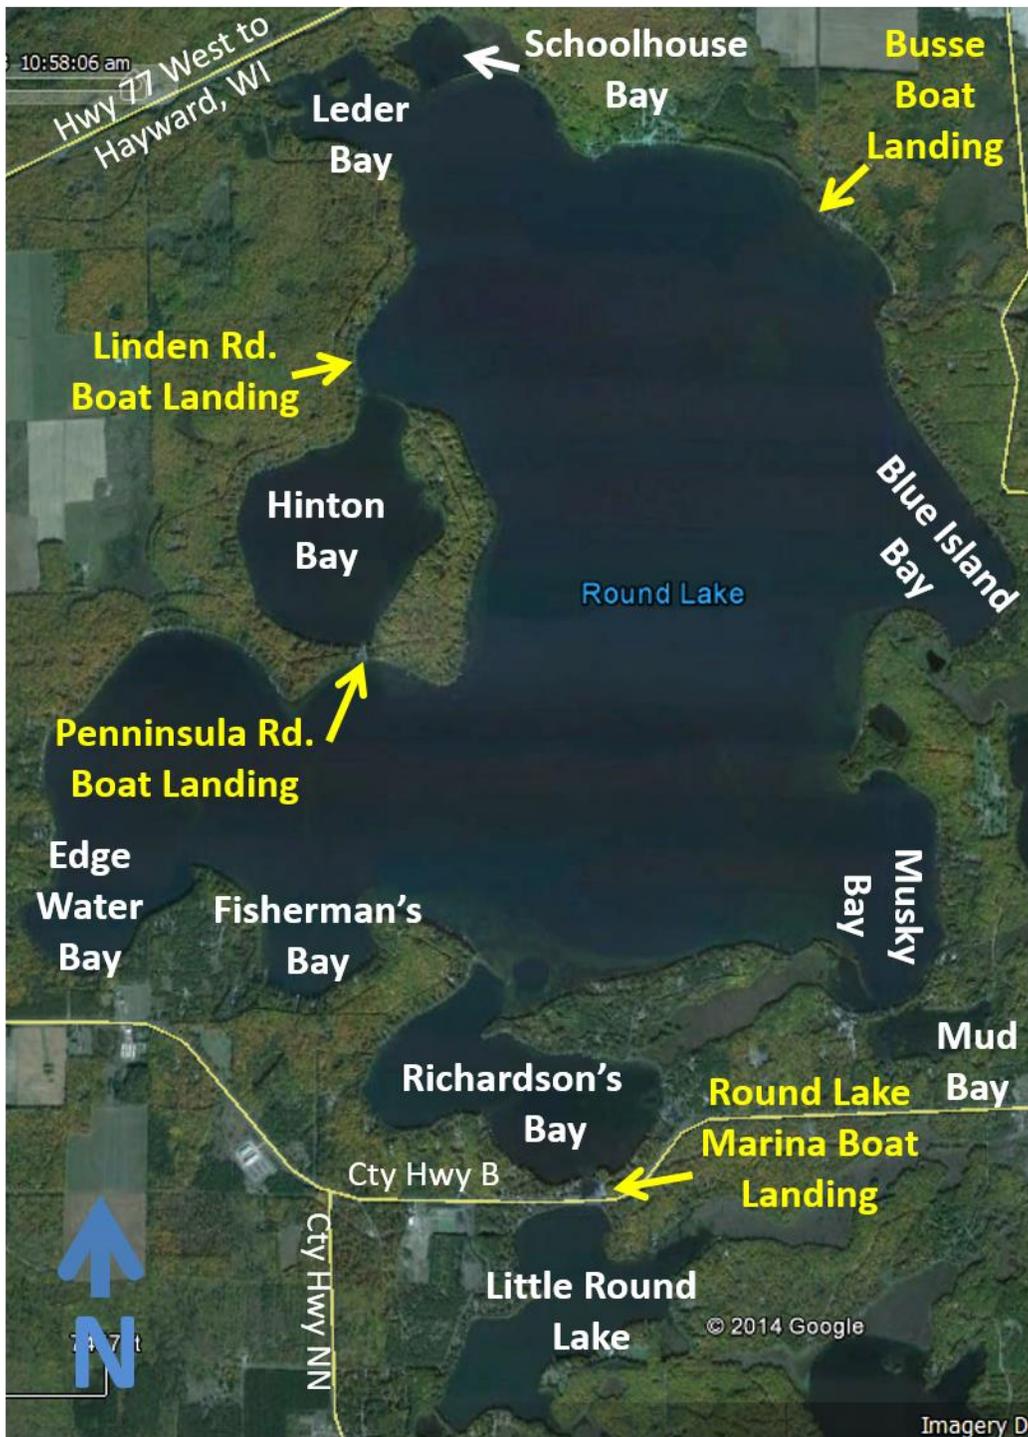
Figure 1 – Round & Little Round Lakes EWM Map

Round Lake is a seepage lake located in Sawyer County, Wisconsin with a surface area of 3,324 acres. The maximum depth is 74 feet and the mean depth is 33 feet. Connected by a narrow channel to the south is Little Round Lake, also considered a seepage lake with a surface area of 179 acres, maximum depth of 38 feet and mean depth of 12 feet. Although the lakes have their own unique Water Body Identification Code (WBIC, Round 2395600, Little Round 2395500), they are sometimes referred to as the Round Chain and the Round Lake Property Owners Association serves both lakes. The lakes are situated approximately 7 miles east of Hayward, Wisconsin (Figure 1). Water clarity for Little Round Lake is clear. Little Round Lake is considered mesotrophic and has abundant vegetation. Water clarity for Round Lake is very high and the lake is considered oligotrophic with low nutrients and sparse vegetation.

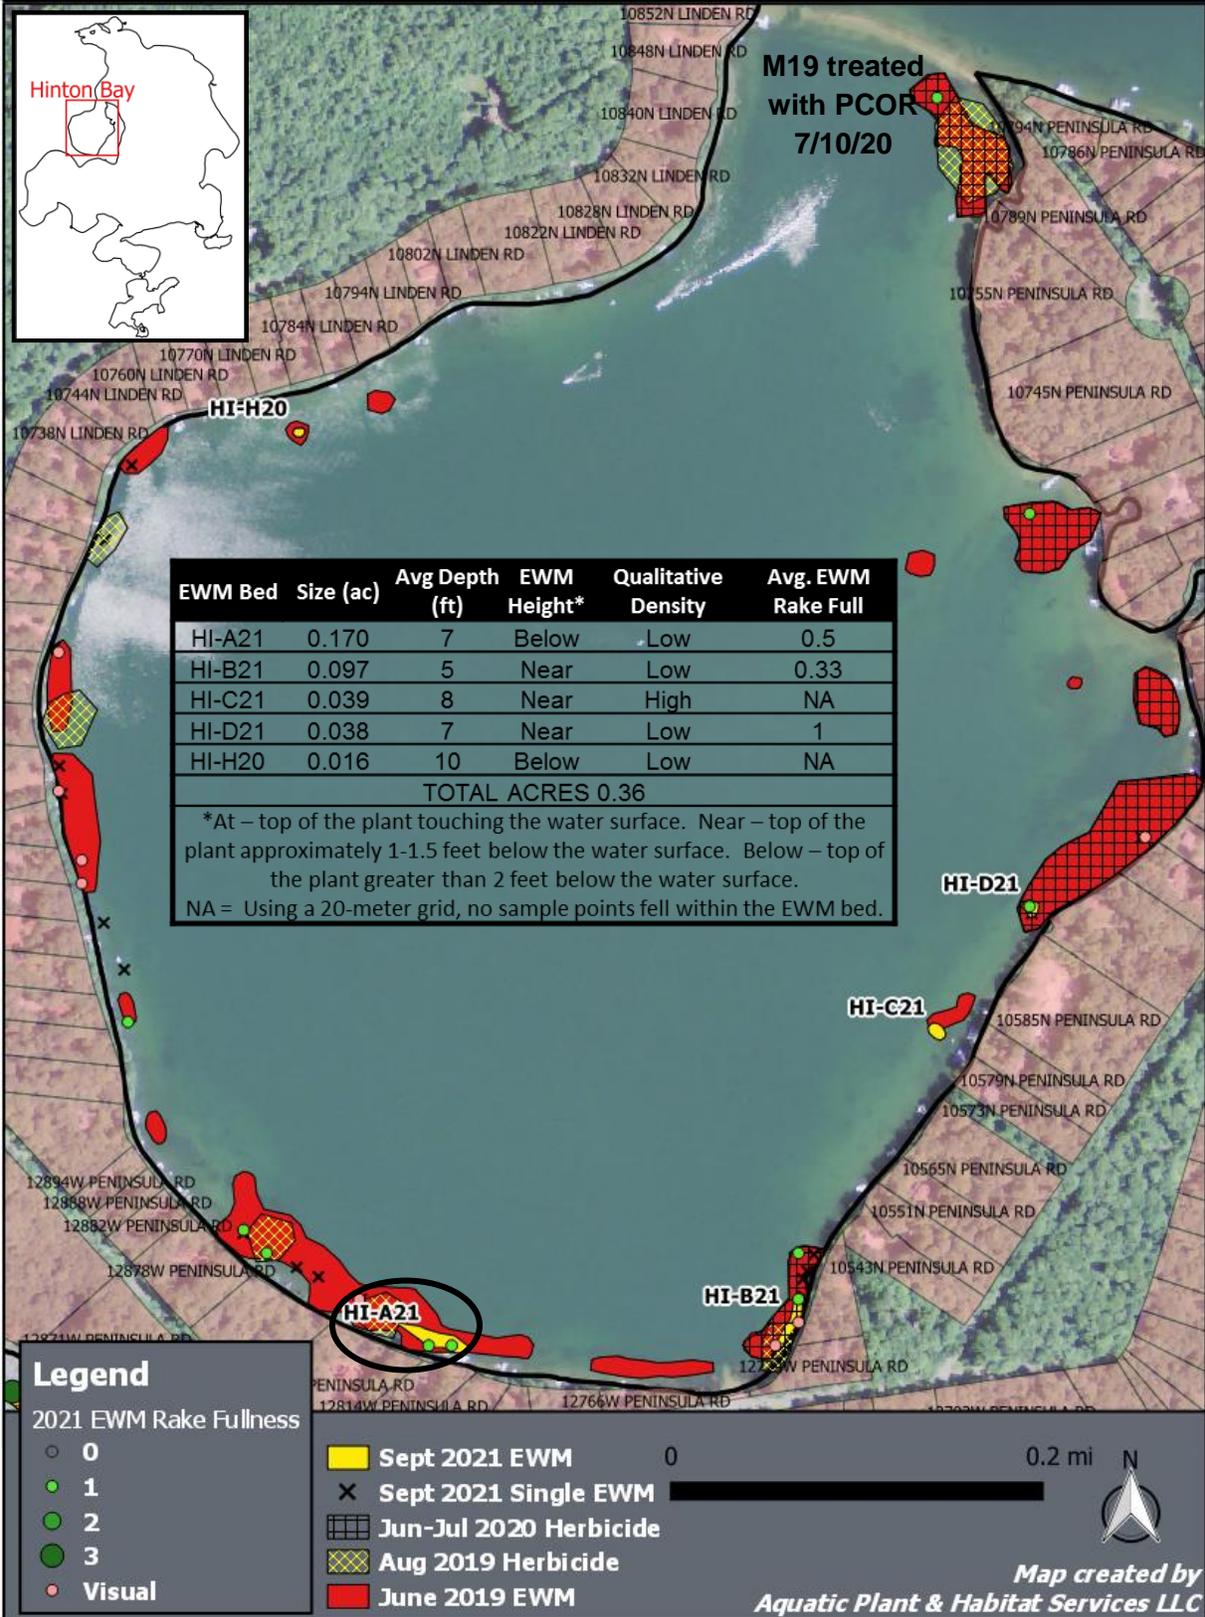
Map 1- Hinton Bay, Round Lake, Sawyer County, Wisconsin Eurasian Watermilfoil Occurrence & Management 2019-2021

There was 0.36 acres of EWM in Hinton Bay in 2021 compared to 0.02 acres 2020, and 9.5 acres in 2019.

The survey of Hinton Bay in 2021 was done at all areas and points treated since 2019. There were 106 sample points in 2021 and EWM was found at 10 sample points (9.4% littoral frequency) and visually observed at another 8 sample points. Chi-squared tests showed that 2021 EWM occurrence was statistically higher in EWM compared to 2020 when EWM was found at 2 of 117 sample points (1.7% littoral frequency), which were the same points sampled in 2021. Chi-squared tests also showed that EWM occurrence in 2021 was significantly lower than 2019 when EWM was found at 61 of 109 sample points within EWM beds (56% littoral frequency).

EWM bed M19 (1.25 acres) was treated with ProcellaCOR (PCOR)⁵ on July 10th, 2020. Within bed M19 there were 19 sample points. In 2019, there were 11 sample points with EWM. EWM was not detected in M19 when surveyed in August 2020 (same year of treatment). Only one small segment of EWM was detected at one sample point in M19 when surveyed in September 2021 (1 year after treatment). There was one native species (fern pondweed) that was statistically lower in 2021 compared to pre-treatment in 2019. There were 3 native species (slender naiad, water celery, & small nitella) that were statistically higher in 2021 compared to pre-treatment in 2019.

EWM Bed	Size (ac)	Avg Depth (ft)	EWM Height*	Qualitative Density	Avg. EWM Rake Full
HI-A21	0.170	7	Below	Low	0.5
HI-B21	0.097	5	Near	Low	0.33
HI-C21	0.039	8	Near	High	NA
HI-D21	0.038	7	Near	Low	1
HI-H20	0.016	10	Below	Low	NA
TOTAL ACRES 0.36					
*At – top of the plant touching the water surface. Near – top of the plant approximately 1-1.5 feet below the water surface. Below – top of the plant greater than 2 feet below the water surface. NA = Using a 20-meter grid, no sample points fell within the EWM bed.

EWM bed HI-A21 is proposed for herbicide treatment in 2022 based on criteria in Figure 5.

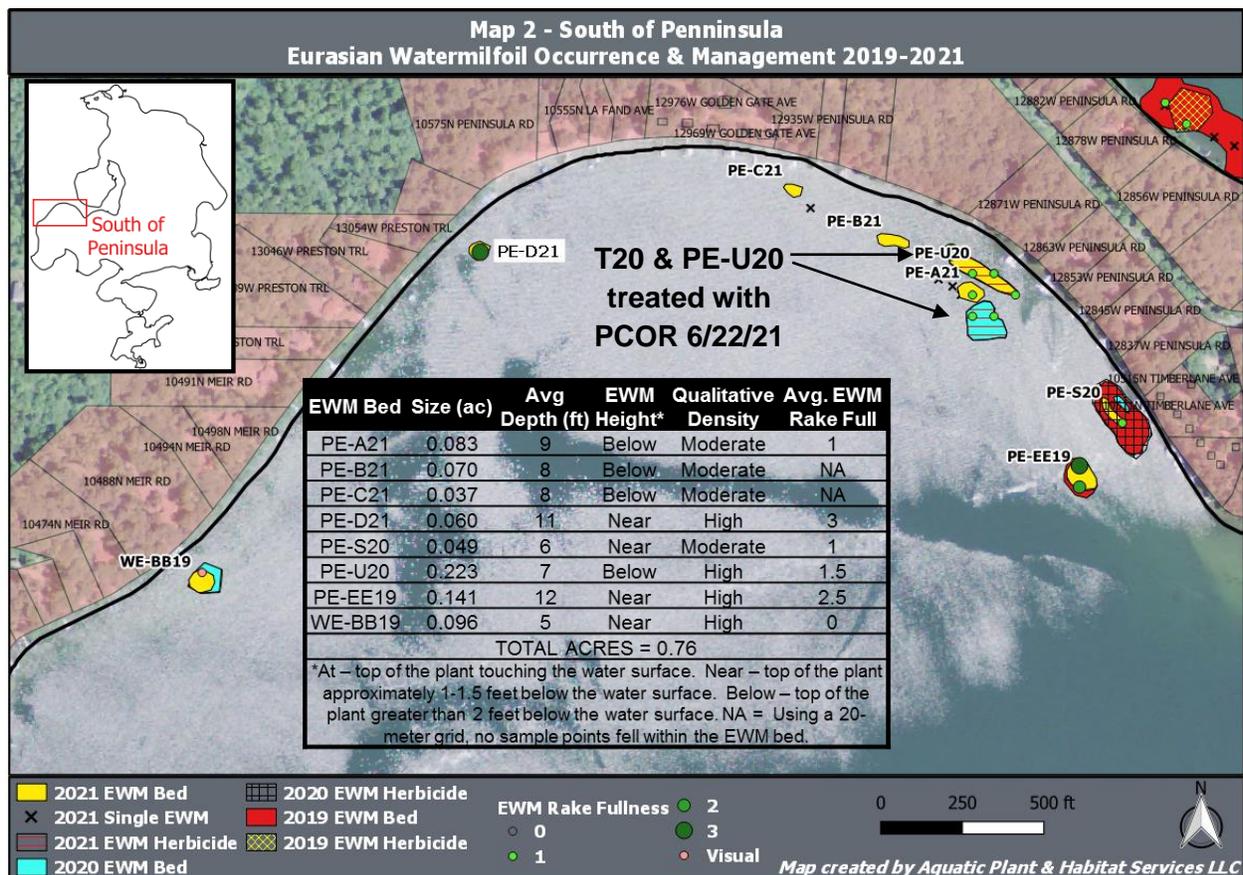
The Southwest region of Round Lake is separated into Maps 2, 3, & 4. There were 16 beds of EWM in the entire region ranging in size from 0.04 to 0.33 acres with a total acreage of 1.82. The largest beds of EWM were in Edgewater Bay (Map 3) and South of the Peninsula (Map 2).

EWM beds T20 & U20 (both 0.25 ac.), and G20 (0.6 ac.) were treated with PCOR (see footnote 5) in late June, 2021. Although EWM was found at 2 sample points within T20 in Sept. 2021, it was low density and not growing near the surface nor causing impairment. The EWM growing at U20 (now PE-U20) was growing near the surface and at high density. Although EWM in bed G20 (map 4) was found at half of the sample points, it was not observed in high density or visible enough from the lake surface to delineate a bed. In conclusion, PCOR treatment was successful at T20, somewhat successful at G20, and unsuccessful at PE-U20 in controlling EWM the same year of treatment. None of the EWM beds treated with PCOR had enough sample points (due to their small size) for a chi-squared test.

EWM beds PE-U20, ED-A21, and ED-D21 are proposed for herbicide treatment in 2022 based on criteria in Figure 5.

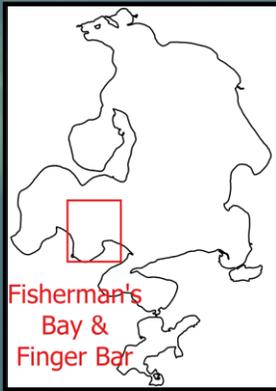
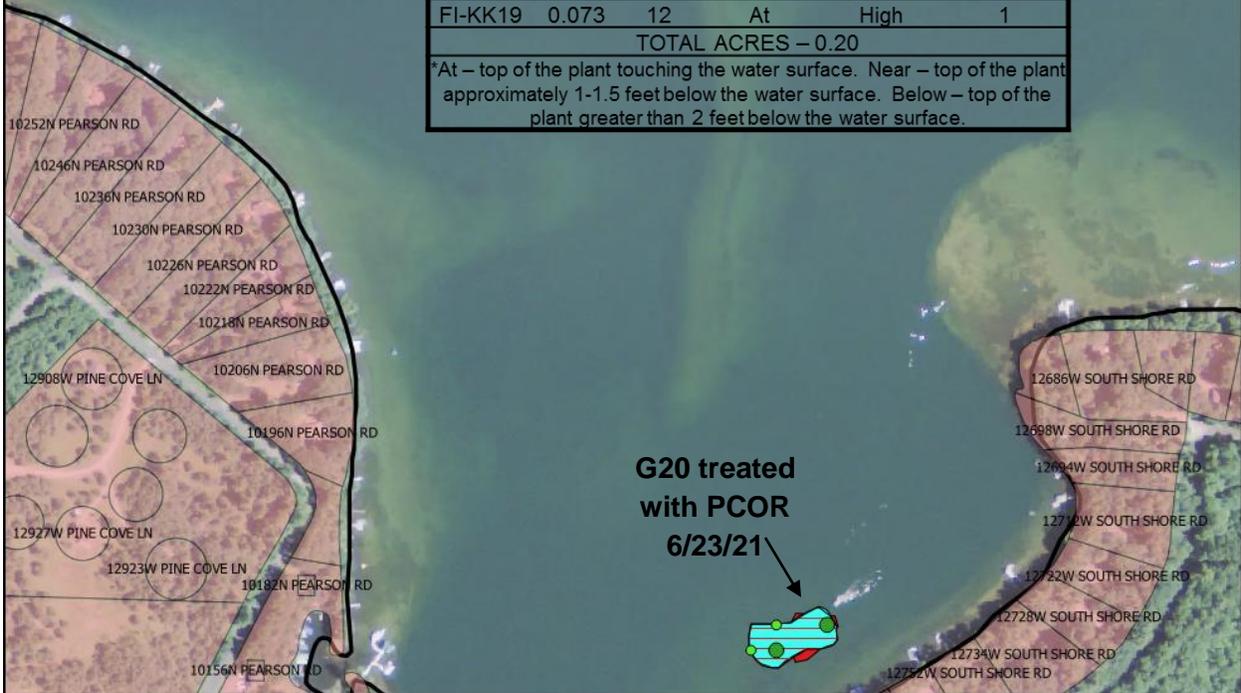
Map 4 - Fisherman's Bay & Finger Bar Eurasian Watermilfoil Occurrence & Management 2019-2021

EWM Bed	Size (ac)	Avg Depth (ft)	EWM Height*	Qualitative Density	Avg. EWM Rake Full
FI-I20	0.131	12	Below	Moderate	1.5
FI-KK19	0.073	12	At	High	1
TOTAL ACRES – 0.20

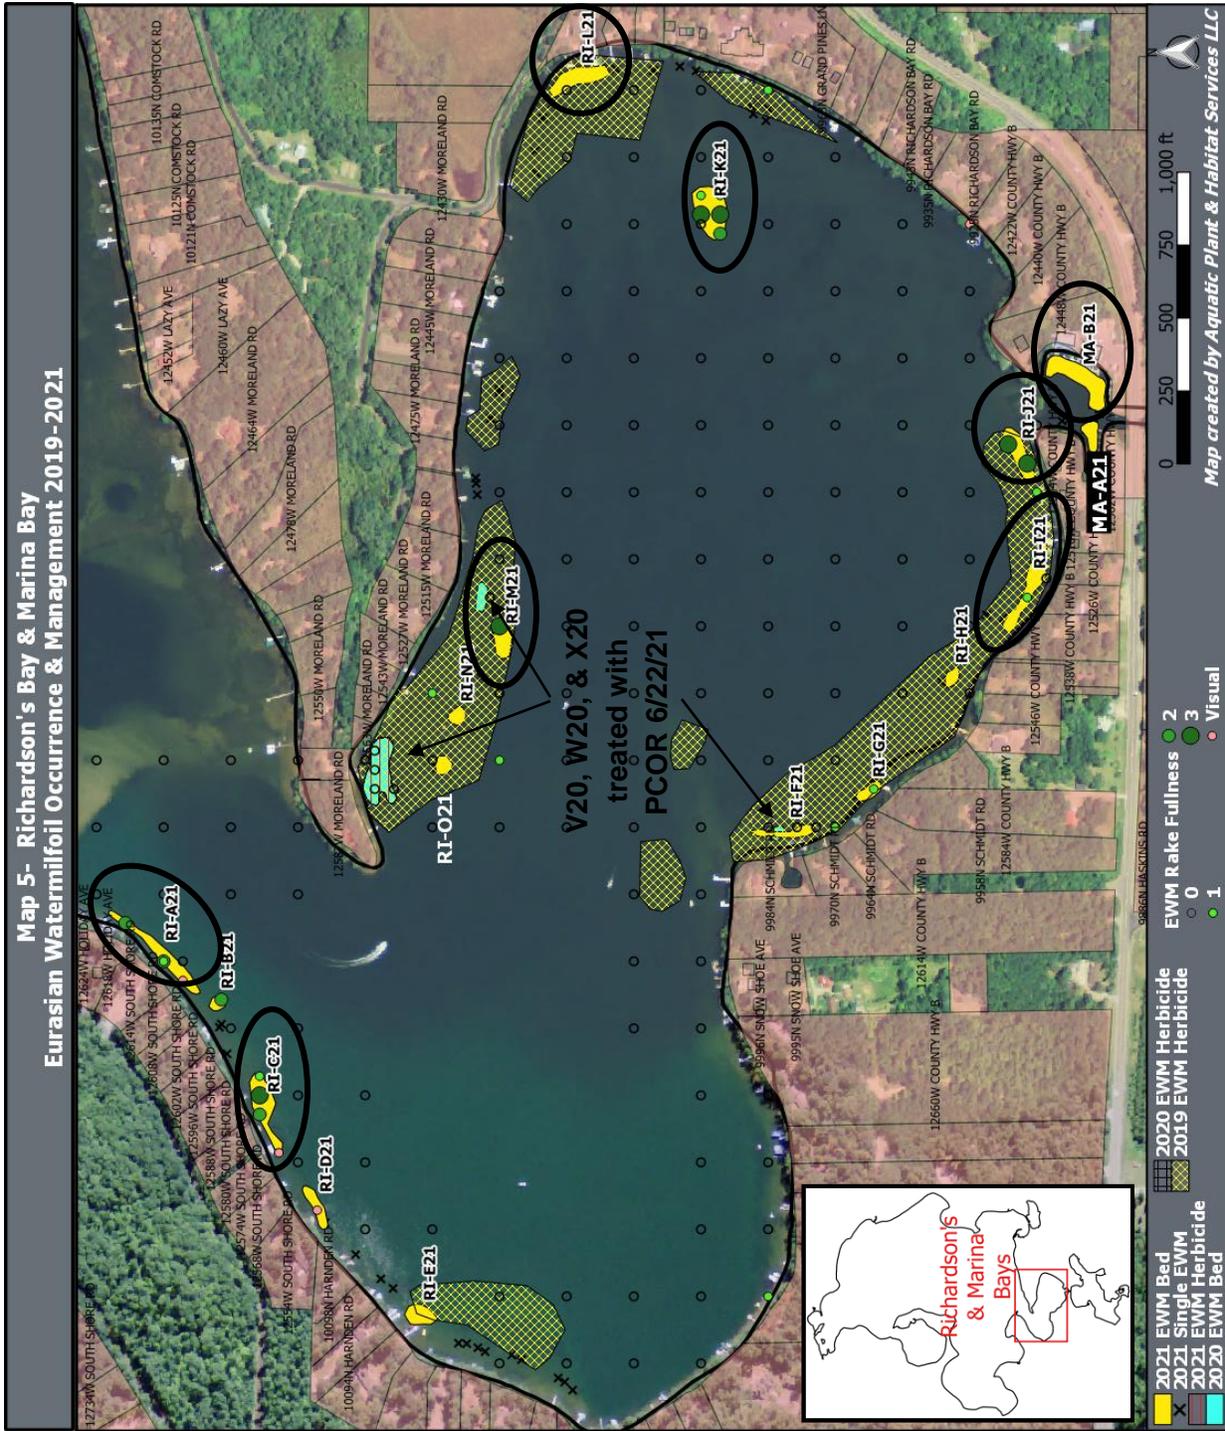
Map 5- Richardson's Bay & Marina Bay
Eurasian Watermilfoil Occurrence & Management 2019-2021

In Richardson’s Bay, there was 2.6 acres of EWM in 2021, 0.5 acres in 2020, and zero acres in 2019, which was the same year as the whole-bay herbicide treatment. In addition to the 2.6 acres in Richardson’s Bay in 2021, there was 0.51 acres of EWM in Marina Bay yielding a total of 3.11 acres in Map 5.

EWM beds V20 (0.25 ac.), W20 (0.04 ac.), and X20 (0.40 ac.) were treated with PCOR (see footnote 5) in late June 2021. No EWM was found growing in X20 or V20. EWM was found growing at W20 in high enough density that a new bed was delineated (RI-F21, 0.12 ac). In conclusion, PCOR treatment was successful at V20 and W20 but unsuccessful at W20 in controlling EWM the same year of treatment. Herbicide concentration monitoring was done at X20 and the results are covered on page 26. None of the EWM beds treated with PCOR had enough sample points (due to their small size) for a chi-squared test.

EWM Bed	Size (ac)	Avg Depth (ft)	EWM Height*	Qualitative Density	Avg. EWM Rake Full
RI-A21	0.299	10	Below-At	Moderate	1.33
RI-B21	0.052	13	Near	Moderate	2
RI-C21	0.292	8	Below-At	Moderate	1.5
RI-D21	0.120	9	Below-At	Moderate	0
RI-E21	0.134	9	Near-Below	Moderate	NA
RI-F21	0.120	6	Near	Low	0
RI-G21	0.081	6	Near	Low	1
RI-H21	0.054	6	Near	Moderate	NA
RI-I21	0.327	4.5	Near-At	Low-Mod	1
RI-J21	0.214	4.5	Near-At	High	3
RI-K21	0.370	7	Near	High	2
RI-L21	0.248	5	Near-At	Moderate	NA
RI-M21	0.159	10	Below	Moderate	NA
RI-N21	0.065	7	Below	Moderate	NA
RI-O21	0.068	10	Below	Low	NA
MA-A21	0.148	5	At	Mod-High	NA
MA-B21	0.362	7	At	Mod-High	NA
TOTAL ACRES = 3.11					
*At – top of the plant touching the water surface. Near – top of the plant approximately 1-1.5 feet below the water surface. Below – top of the plant greater than 2 feet below the water surface. NA = Using a 20-meter grid, no sample points fell within the EWM bed.

There are 8 EWM beds circled in Map 5 being proposed for herbicide treatment in 2022 based on criteria in Figure 5.

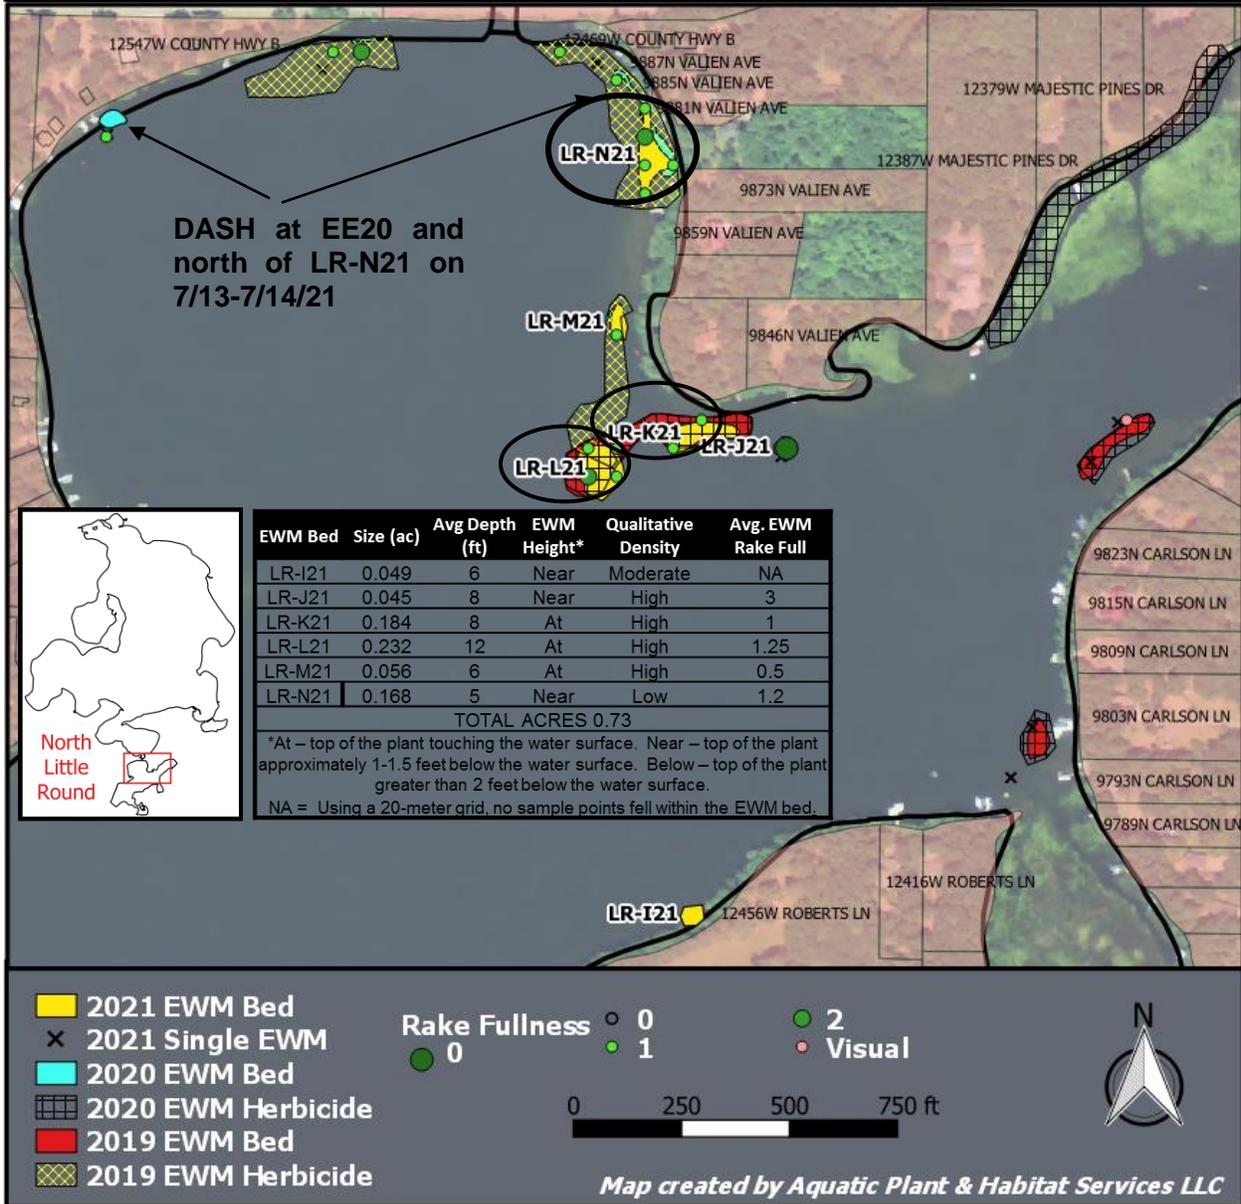
Map 6 - Northern Little Round Lake Eurasian Watermilfoil Occurrence & Management 2019-2021

Little Round Lake is separated into a northern and southern map. There was a total of 1.9 acres of EWM in 2021 compared to 0.34 acres in 2020 and 1.9 acres in 2019. The 1.9 acres of EWM is among 14 beds ranging in size from 0.05 to 0.27 acres. The three largest beds were LR-B21 and LR-D21 located in the southwestern area of the lake and LR-L21 in the north central region.

There were two areas in northern Little Round Lake where diver assisted suction harvesting (DASH) was used to control EWM in 2021 on July 13-14, 2021. Those areas are labeled in Map 6 and included EE20 (0.04 acres) and an area north of LR-N21 (0.02 acres). Approximately 2 months later when the areas were surveyed, EWM was observed but in very low abundance and not dense enough to delineate EWM beds in those areas.

There are 7 EWM beds circled in Maps 6 and 7 being proposed for herbicide treatment in 2022 based on criteria in Figure 5. Following herbicide treatment of these beds, DASH will be used to "mop up" EWM plants or clumps that remain. This use of integrated pest management is intended as a trial in Little Round Lake to determine whether herbicide closely followed by DASH will improve EWM control in those areas. If time allows, other small beds of EWM in Little Round Lake may be targeted for DASH control.

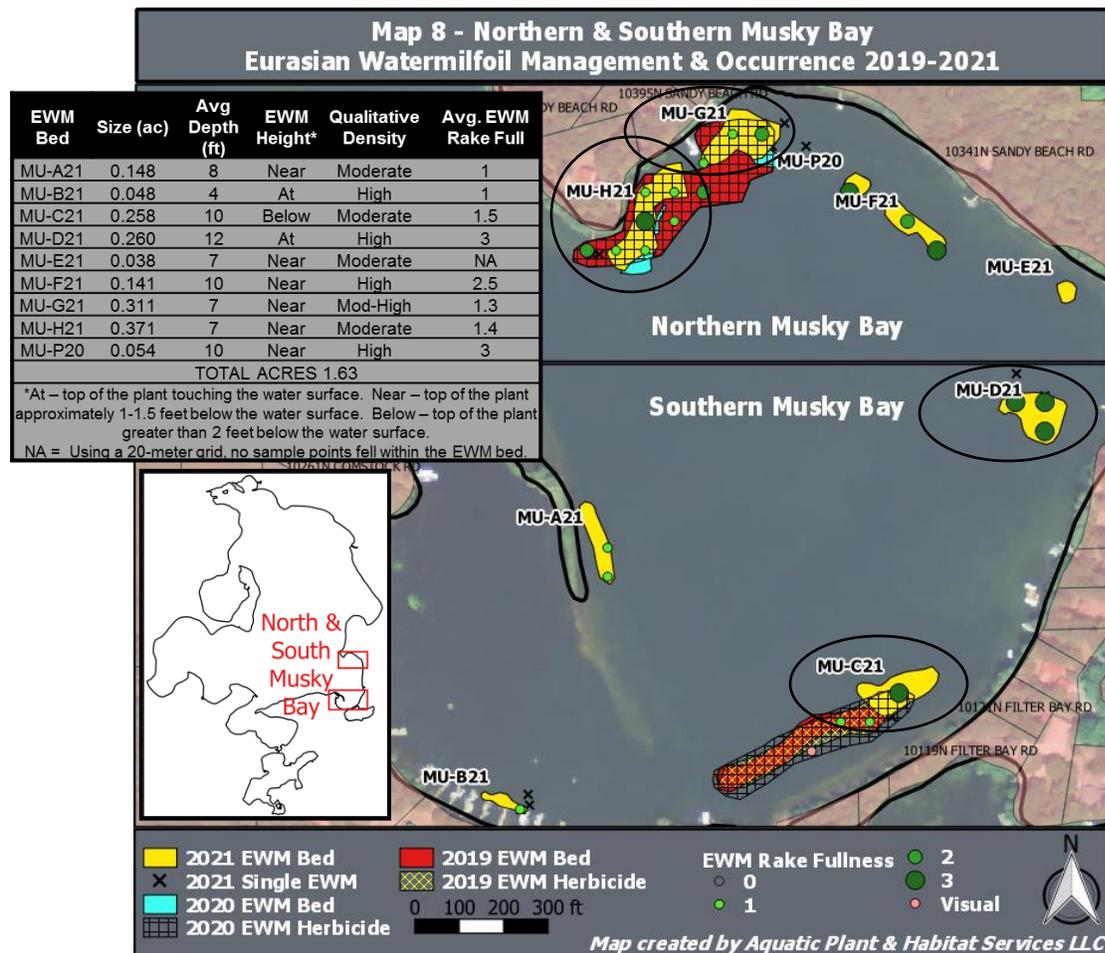
Map 8 – North & South Musky Bay

There was a total of 1.63 acres of EWM in 2021 compared to 0.42 acres in 2020 and 1.8 acres in 2019. The 1.63 acres in 2021 was among 9 beds ranging in size from 0.04 to 0.37 acres. The largest beds of EWM are in northern Musky Bay at beds MU-G21 and MU-H21.

There was no herbicide treatment or DASH to control EWM in Musky Bay in 2021 due to the low EWM acreage in 2020. Four new beds of EWM that were not previously detected were mapped in 2021 including MU-D21, which was very dense EWM canopied in 12 feet of water. The other new beds of EWM were MU-A2, MU-E21, and MU-F21 all of moderate-to-high density.

There are 4 EWM beds circled in Map 8 being proposed for herbicide treatment in 2022 based on criteria in Figure 5.

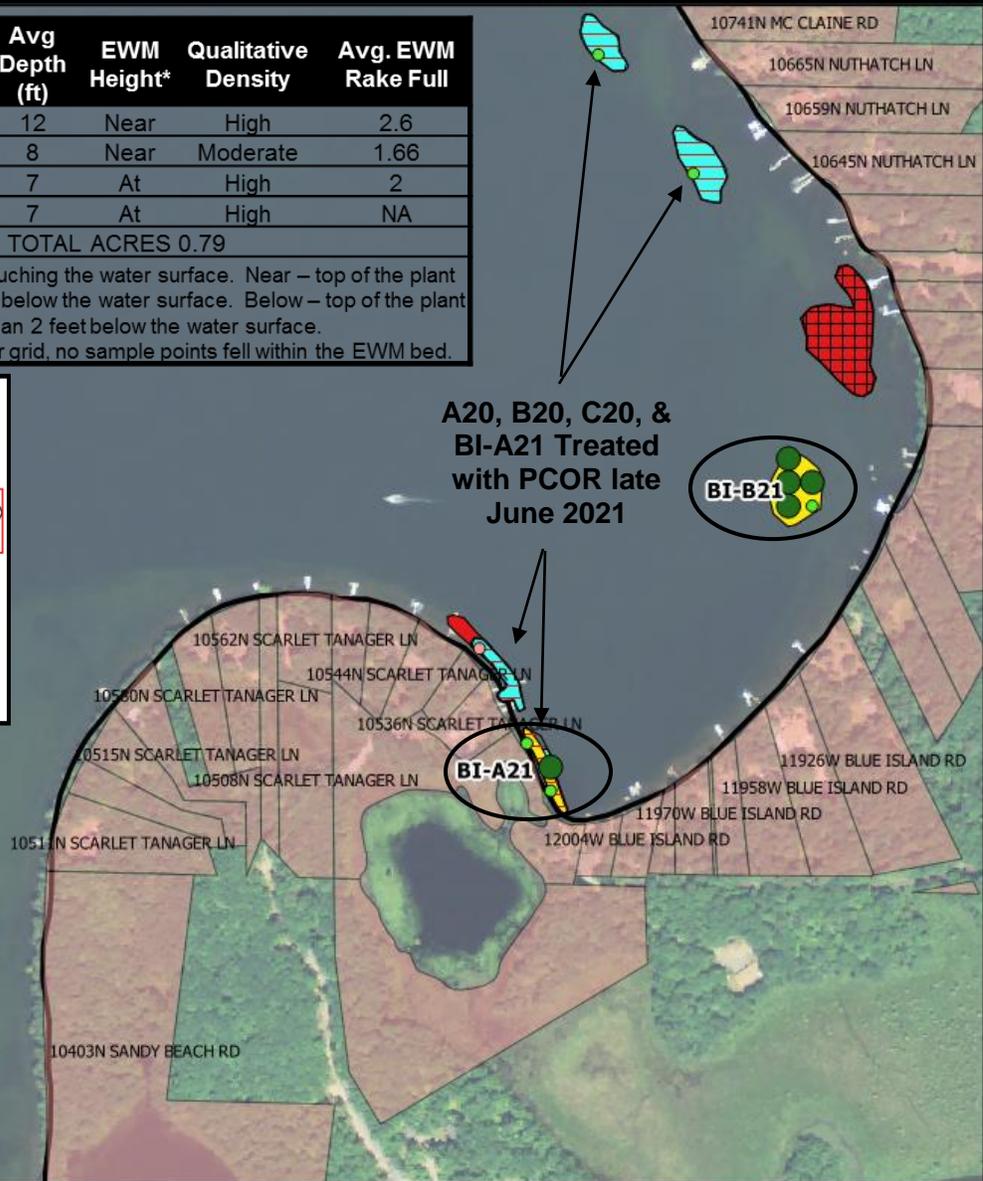
Map 9 - Blue Island Bay & Sandy Bar Eurasian Watermilfoil Occurrence & Management 2019-2021

In Blue Island Bay, there was a total of 0.67 acres of EWM in 2021, 0.92 acres in 2020, and 1.2 acres in 2019. There were two beds of EWM in 2021 at sizes of 0.15 and 0.52 acres.

There were two newly documented beds of EWM in the Sandy Beach area which is located near the east-central shoreline of Round Lake. These beds of EWM are 0.04 and 0.08 acres in size.

EWM beds A20 (0.27 ac.), B20 (0.39 ac.), C20 (0.18 ac.) and D20 (0.09 ac., currently labeled BI-A21) were treated with PCOR (see footnote 5) in late June 2021. Although EWM was found at 1 sample point in each of A20, B20, and C20 in September 2021, the EWM was low density or a few single plants and not growing near the surface nor causing impairment. The EWM growing at BI-A21 (previously D20) was canopied and at high density. In conclusion, PCOR treatment was successful at A20, B20, and C20 but unsuccessful at BI-A21 in controlling EWM the same year of treatment. Herbicide concentration monitoring was done at C20 and the results are covered on page 26. None of the EWM beds treated with PCOR had enough sample points (due to their small size) for a chi-squared test.

EWM Bed	Size (ac)	Avg Depth (ft)	EWM Height*	Qualitative Density	Avg. EWM Rake Full
BI-B21	0.515	12	Near	High	2.6
BI-A21	0.151	8	Near	Moderate	1.66
SA-A21	0.081	7	At	High	2
SA-B21	0.043	7	At	High	NA
TOTAL ACRES 0.79

EWM beds BI-A21 and BI-B21 are proposed for herbicide treatment in 2022 based on criteria in Figure 5.

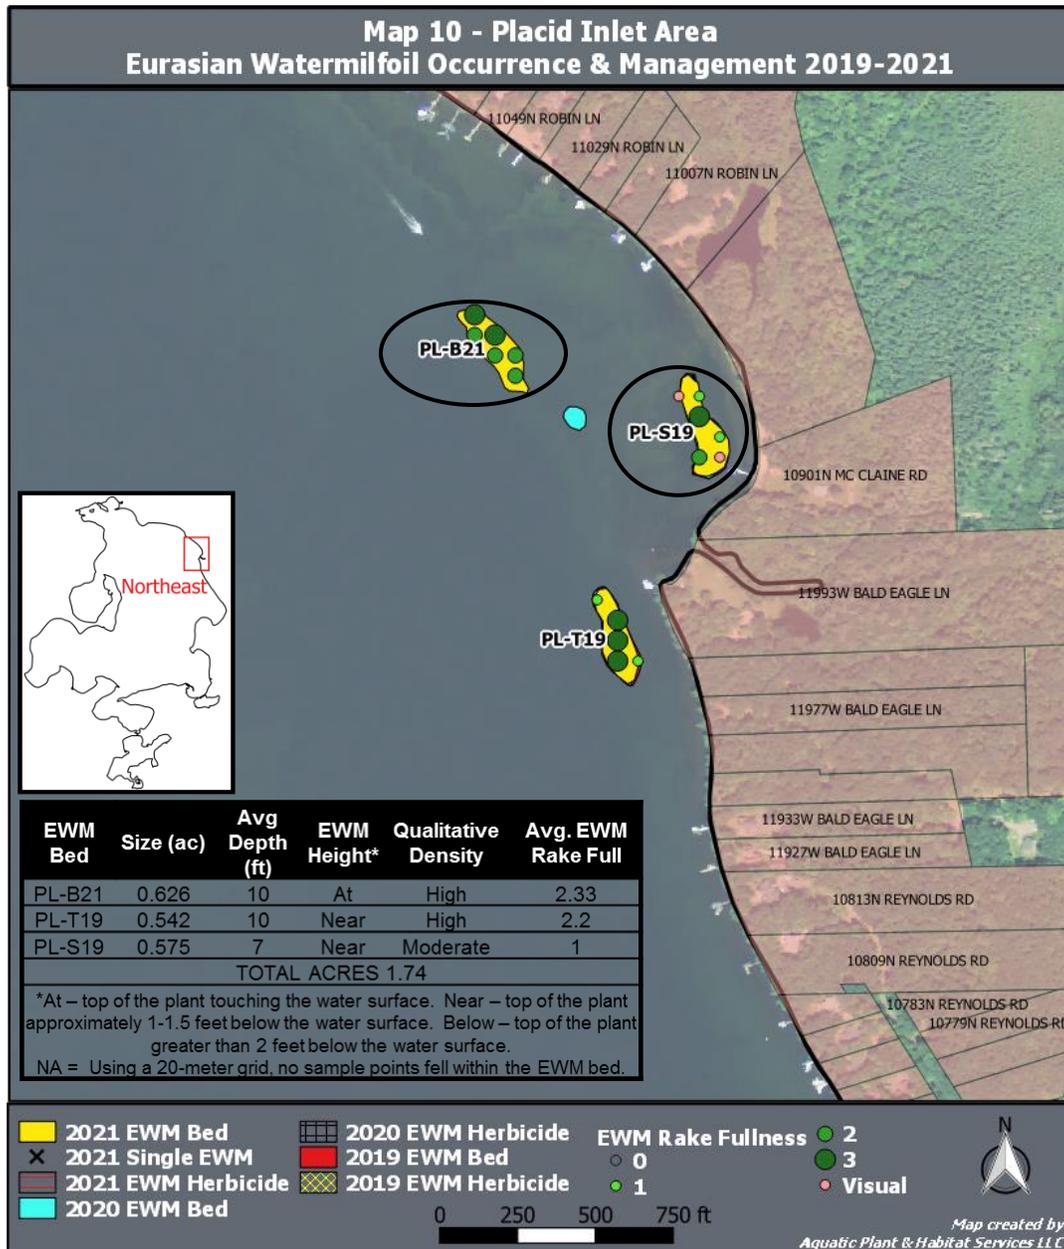
Map 10 – Placid Inlet Area

In the far northeast region of the lake, also labeled in this report as the Placid Inlet area, there was a total of 1.74 acres of EWM in 2021, 1.19 acres in 2020, and 1.10 acres in 2019. There were two beds of EWM in 2021 at sizes of 0.15 and 0.52 acres. Two beds have stayed about the same size since they were first delineated in 2019 (PL-S19 and PL-T19). PL-B21 was a new EWM bed in 2021 and was 0.63 acres of high density EWM canopied at the lake surface.

EWM beds PL-B21 and PL-S19 are proposed for herbicide treatment in 2022 based on criteria in Figure 5.

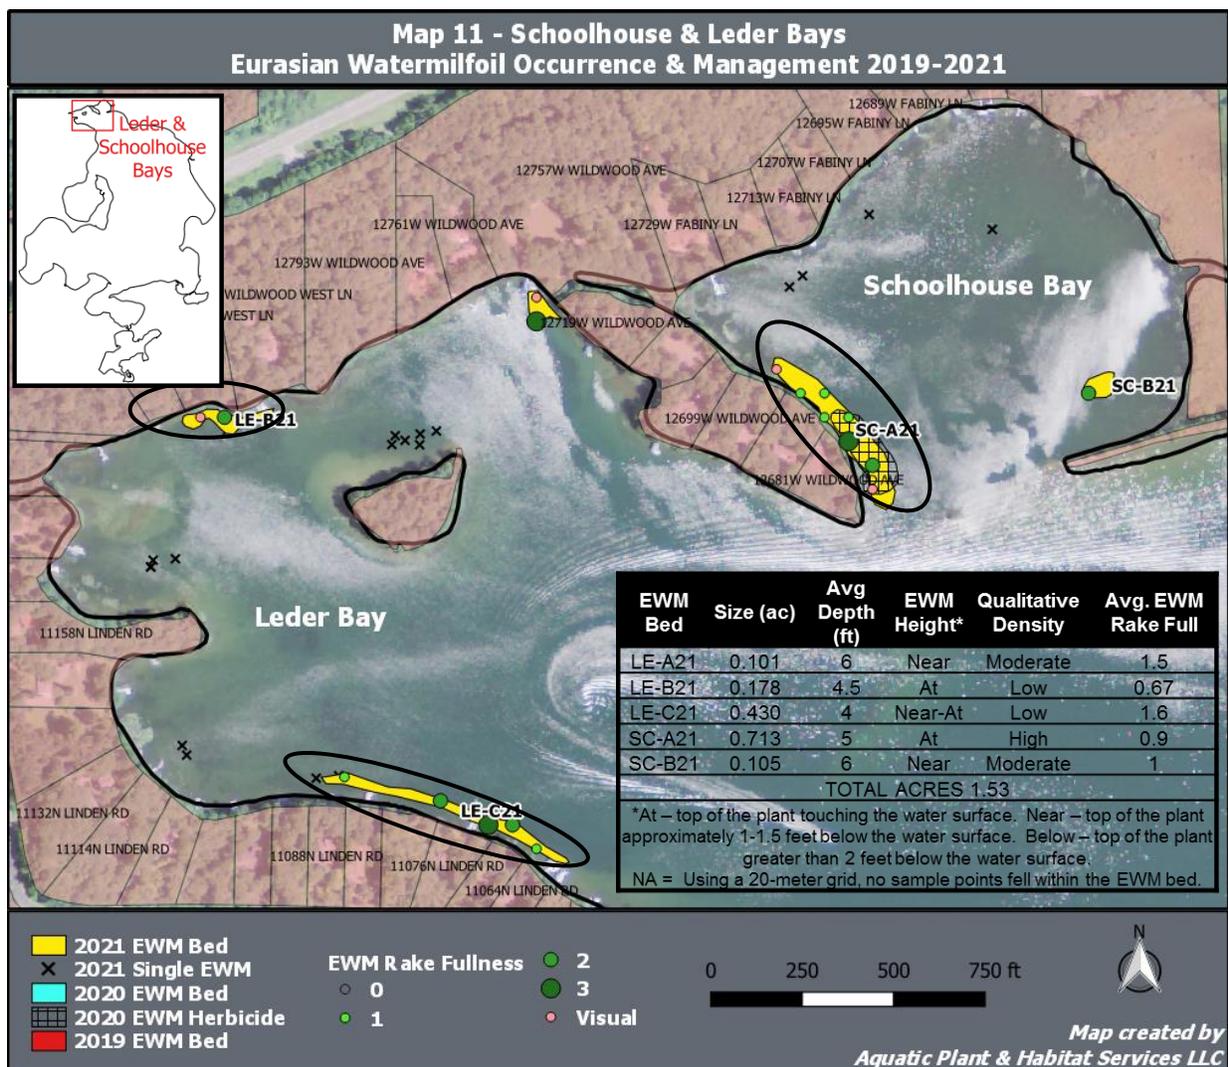
Map 11 – Schoolhouse & Leder Bays

EWM was at 1.53 acres in this area of the lake in 2021 compared to 0.23 acres in 2020 and zero acres in 2019 although single EWM plants or clumps were noted that year. There were 5 beds of EWM ranging in size from 0.10 acres to 0.71 acres.

EWM beds SC-A21, LE-B21, and LE-C21 are proposed for herbicide treatment in 2022 based on criteria in Figure 5.

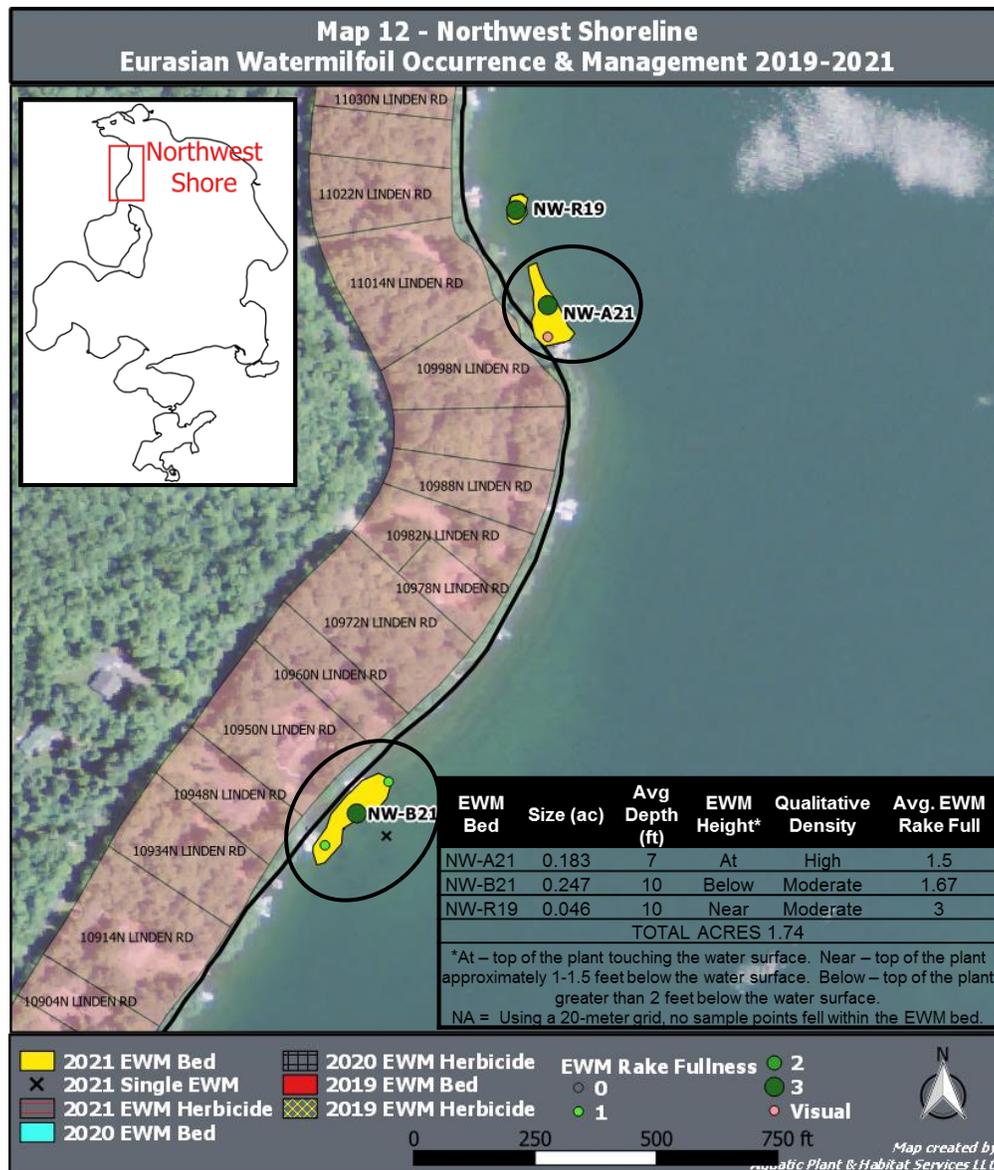
Map 12 – Northwest Round Lake

EWM was at 0.48 acres in this area of the lake in 2021 compared to 0.10 acres in 2020 and 0.02 acres in 2019. There were 3 beds of EWM ranging in size from 0.05 acres to 0.25 acres. NW-R19 has remained the same size and density since 2019. NW-A21 was first delineated in 2020 (then labeled K20) and has grown in size.

EWM beds NW-A21 and NW-B21 are proposed for herbicide treatment in 2022 based on criteria in Figure 5.

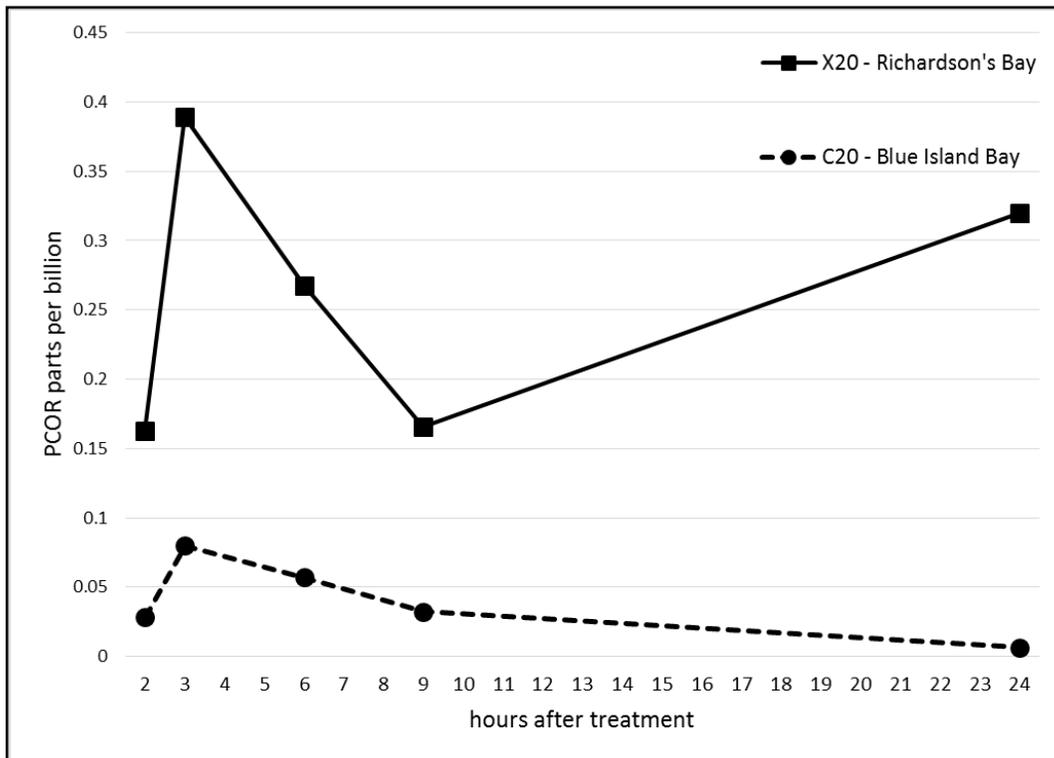
Figure 4 – PCOR Monitoring Results

Two locations were sampled after herbicide treatment in 2021 to monitor concentrations of the herbicide ProcellaCOR. Volunteers collected samples at 2, 3, 6, 9, and 24 hours after treatment (HAT), preserved the samples and sent them to a laboratory for analysis. The results are illustrated in Figure 4. The concentrations found in the Richardson Bay treatment area (X20) were about 5 times that of the concentrations found at the Blue Island Bay treatment area (C20). This may have been because X20 was more protected and larger in size whereas C20 was smaller and covered a narrow strip of EWM between shore and a steeply sloped lake bottom. Even though the concentrations of PCOR was very different for both sites, the control of EWM in 2021 was perceived as successful at these two locations because EWM was not detected at X20 and only one occurrence of EWM was recorded at C20.
